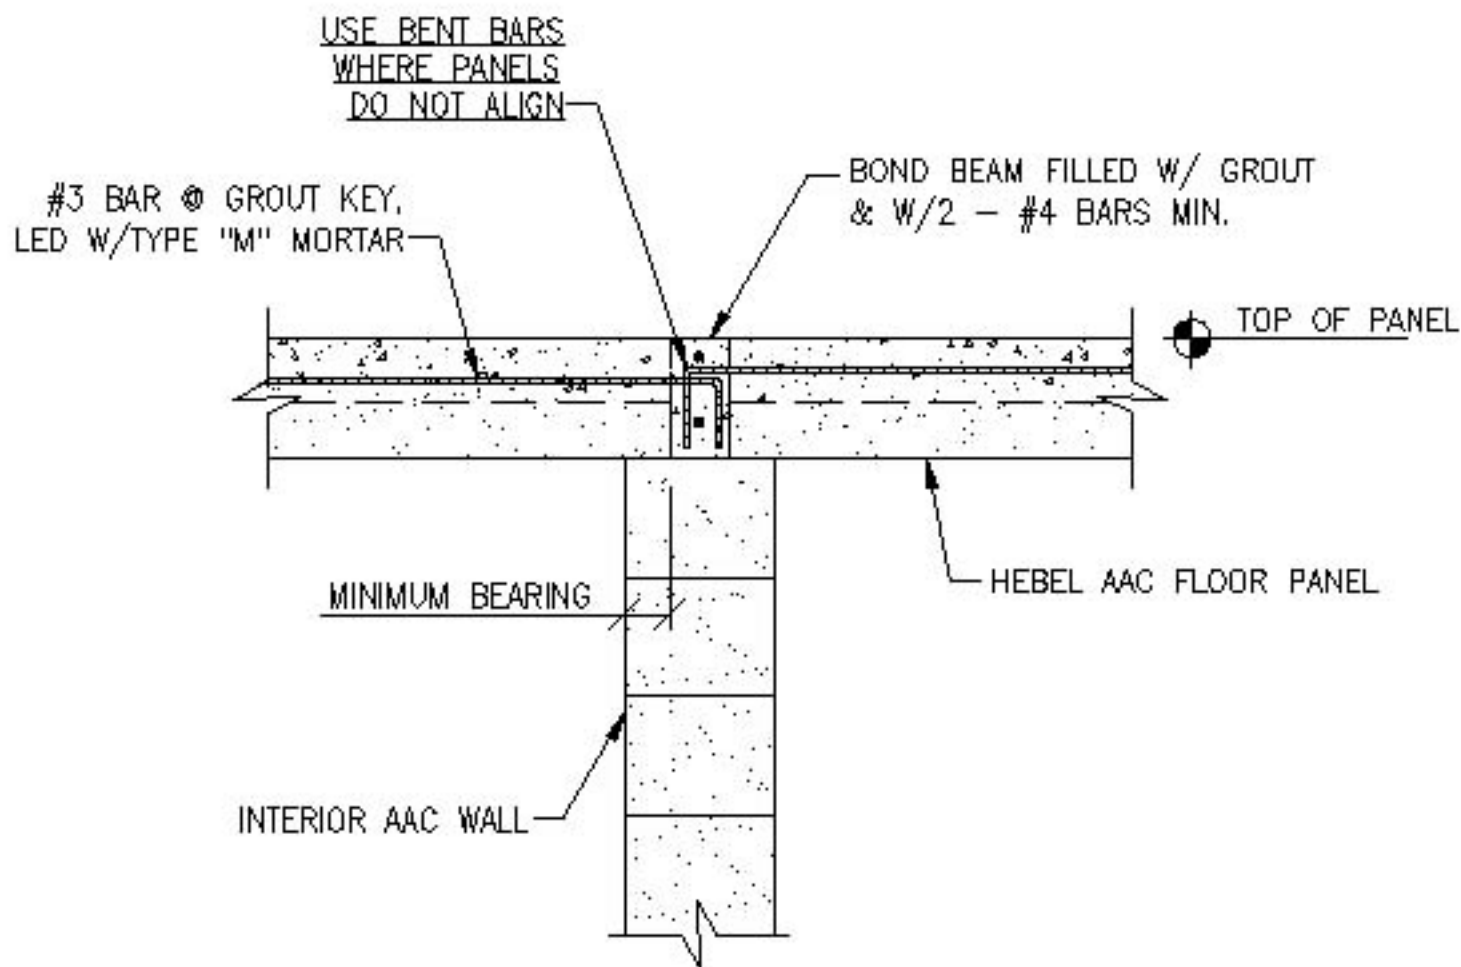
NON-ALIGNED GROUT KEY
FLOOR PANELS @ BOND BEAM
